USAAEFA PROJECT NO. 74-20

## HOT BRICK III AIRWORTHINESS EVALUATION OV-10 AIRPLANE

### FINAL REPORT

NOVEMBER 1974

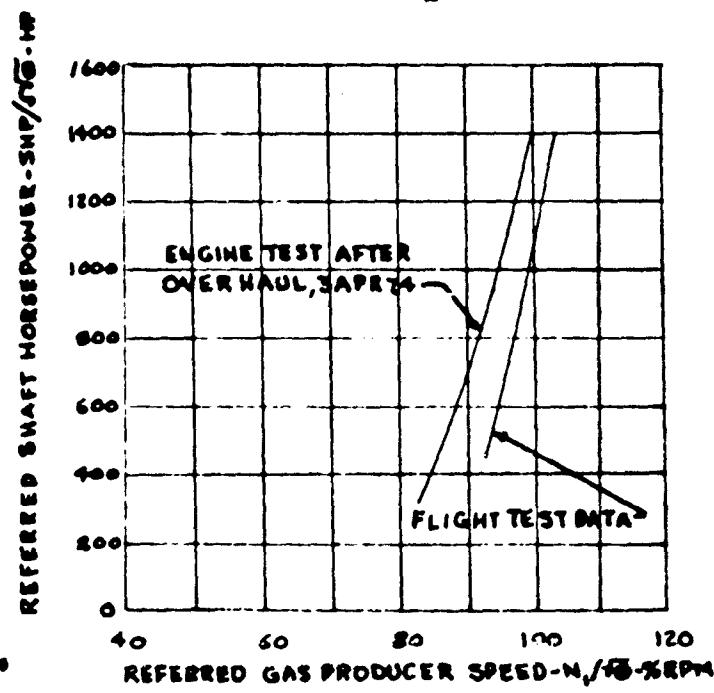
FIGURE NO 1  
ENGINE CHARACTERISTICS  
OV-10 USA %69-17000  
T53-701A %30036

12. This figure shows that the engine was apparently developing 300 to 400 shp less than during the test stand run. To verify this, a lift-drag polar was calculated from the data obtained during the airspeed position error calibration in the cruise configuration, using the following equations:

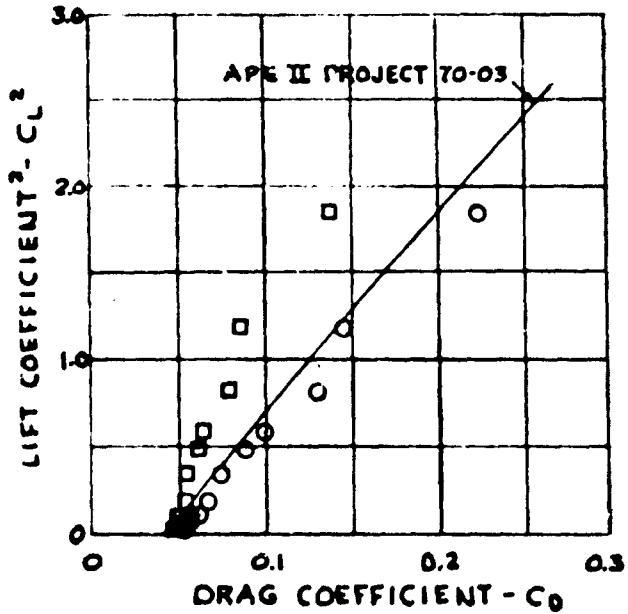
FIGURE NO. 2

14. Figure 2 shows that a considerable increase in performance (*i.e.*, less power required for a given gross weight and airspeed) is indicated when basing power on the engine torquemeter. Also shown on figure 2 is a lift-drag polar calculated from the data obtained during the airspeed position error calibration in the cruise configuration, using power based on the engine test stand run after overhaul and gas producer speed. This power was obtained in the following manner. The gas producer speed recorded in flight was referred to sea-level, standard-day conditions. This referred gas producer speed was used to enter a plot of referred gas producer speed versus referred shp derived from the engine test stand run after overhaul to obtain referred shp. Shaft horsepower at the test conditions was determined from referred shp using the following equation:
